Inspected
(727) 291-3322
www.InspectedFL.com

Home Inspection Report
12083 Pine Club Circle
Brooksville, FL 34614

Inspected By: Jason Hebert HI1422

Prepared For: Patricia Montecki
Inspected On Wed, Oct 16, 2024 at 12:17 PM

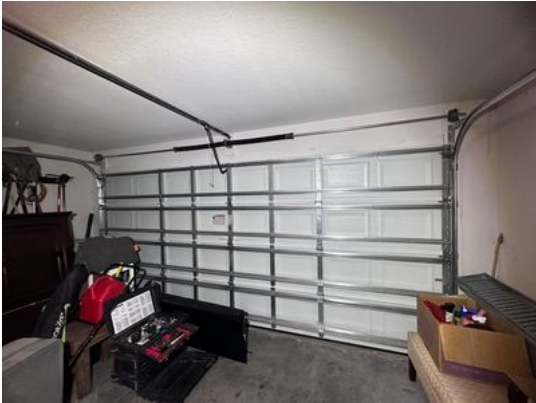
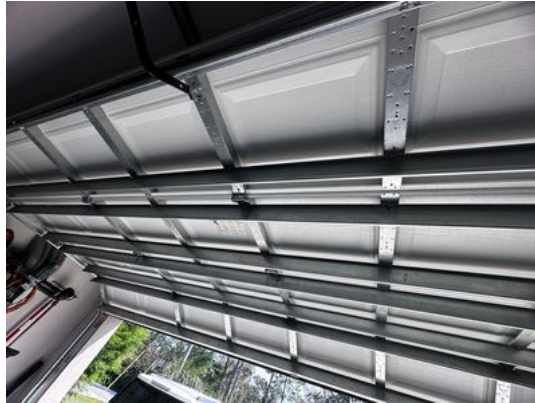
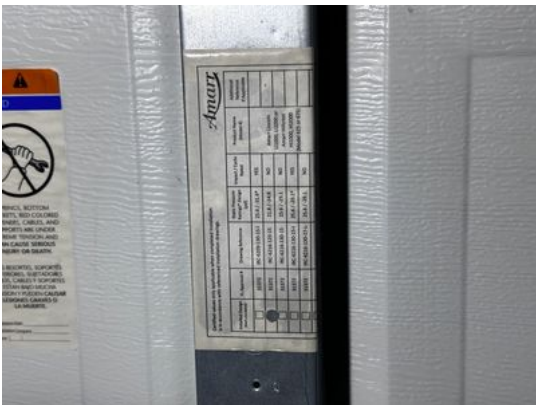
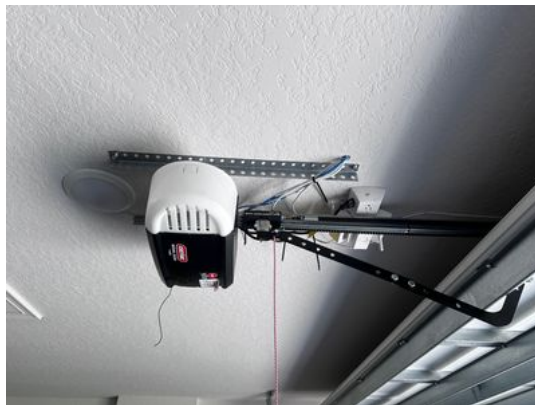
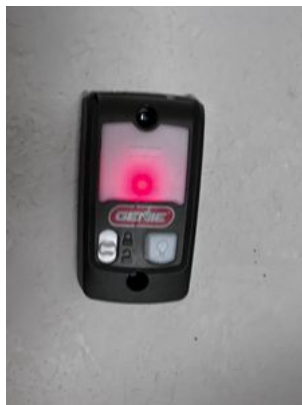
Garage pictures

During the inspection of the property, it was observed that the garage contained a significant amount of storage and personal items at the time of the inspection. The presence of these items made it challenging to thoroughly assess the condition of the garage and its components. It is important to note that the clutter and belongings may obstruct visibility and hinder the inspector's ability to identify potential issues or areas of concern.

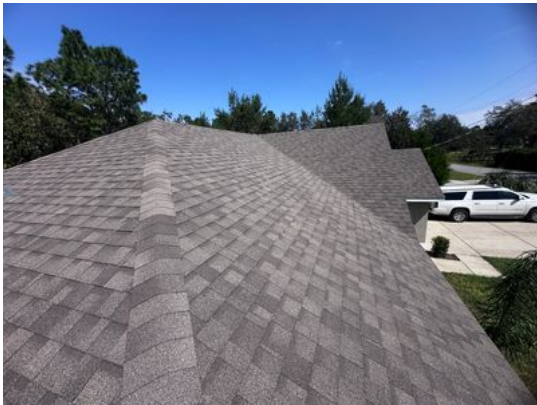
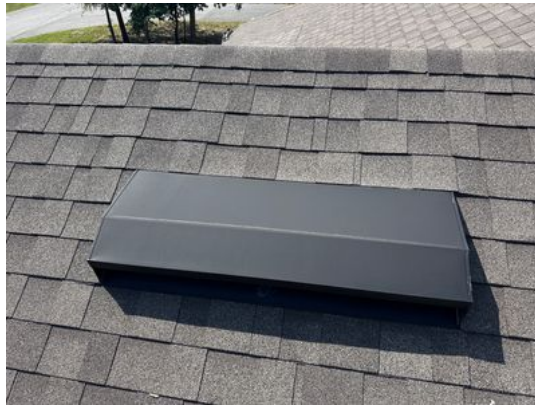
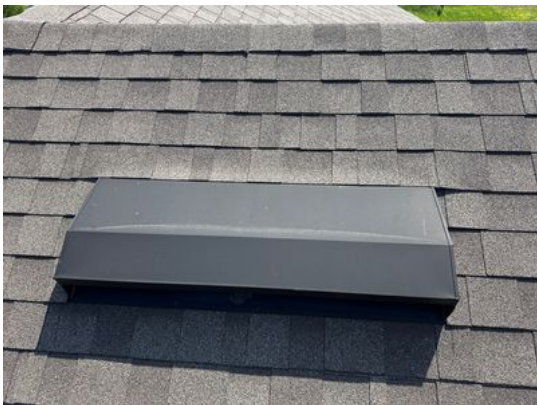
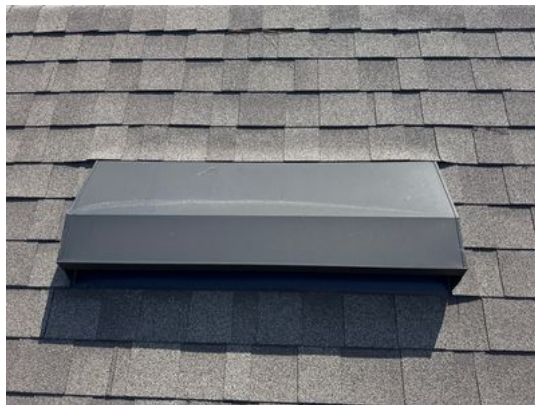
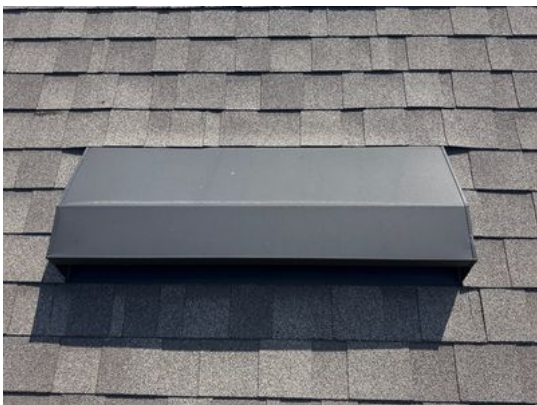
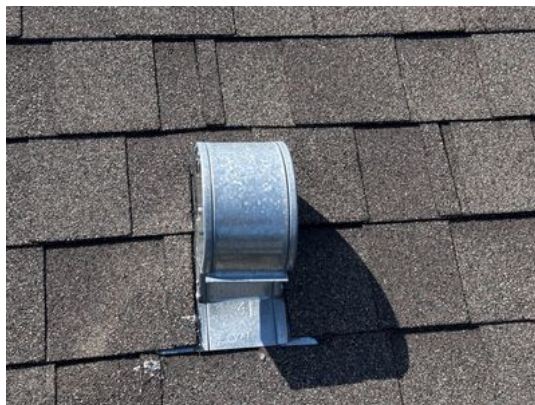
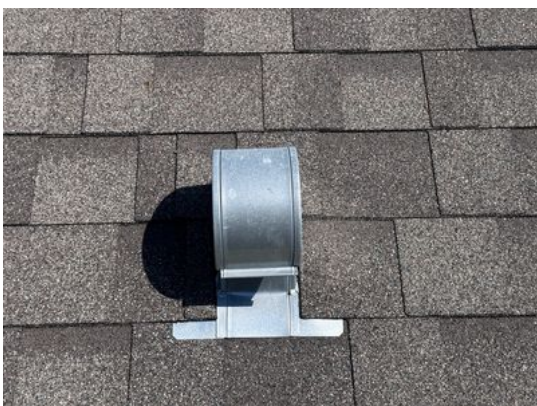
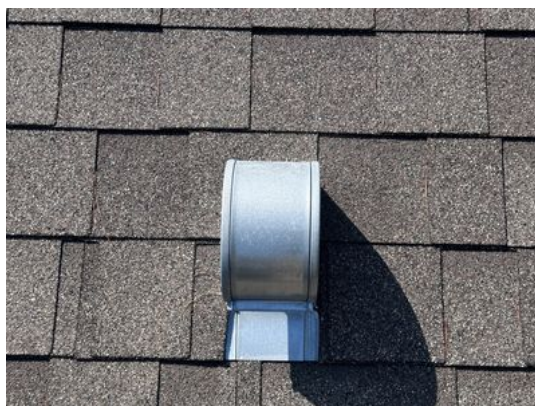
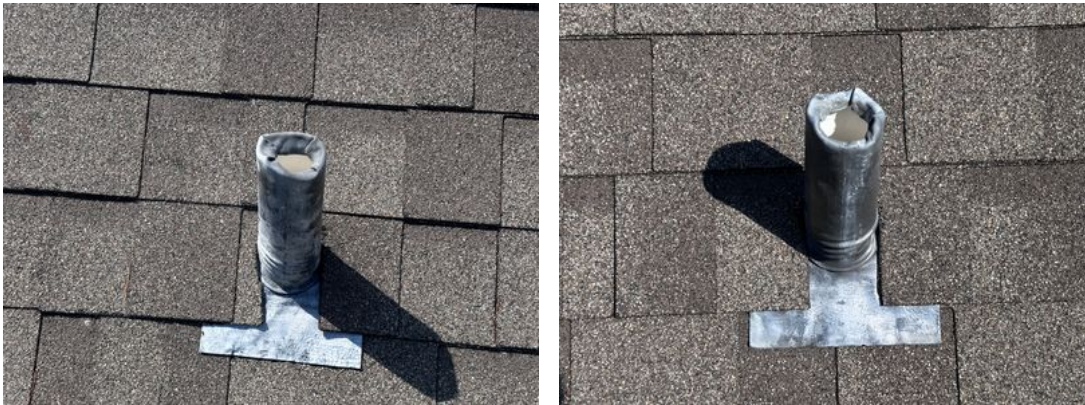
Roof pictures

Two popped nails were noted on the roof on the south side. This condition may compromise the integrity of the roofing material and could lead to water infiltration if not addressed.

Recommend having a qualified roofing contractor repair the popped nails and inspect the surrounding area for any additional issues. Proper securing of roofing materials is essential to maintain the roof's integrity and prevent leaks. Regular inspections of the roof are advised to catch such issues early.

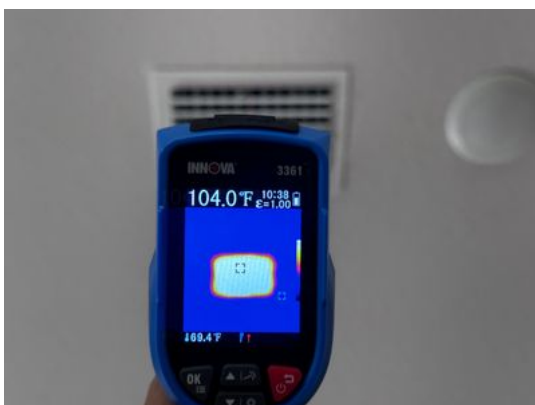
Comment 5 Information

Heat temperature

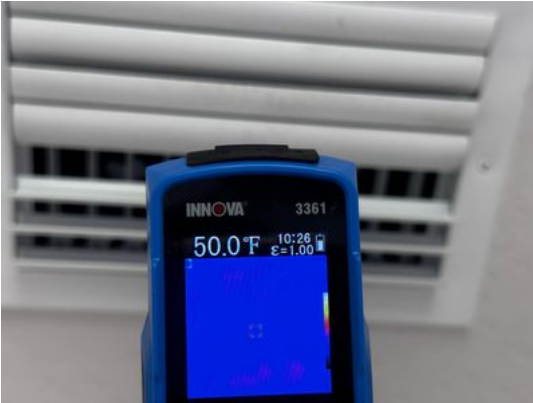
Supply air temperature

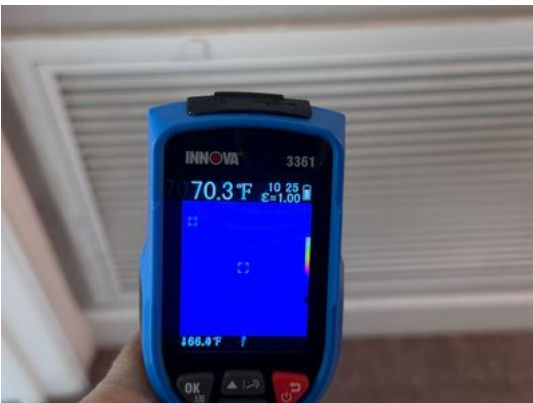
Return air temperature

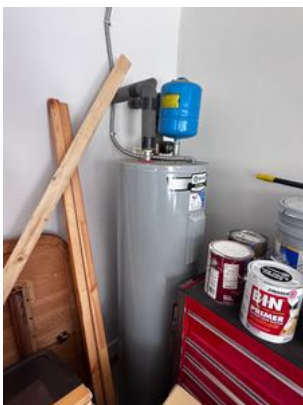
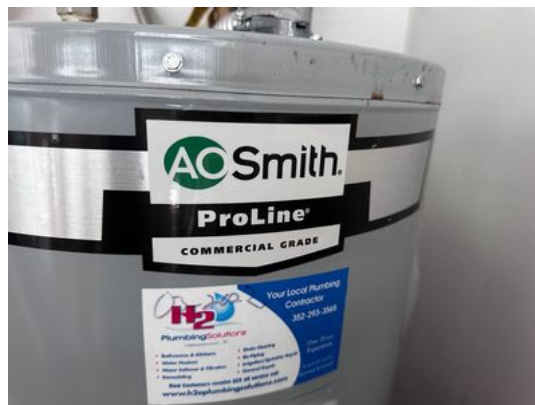
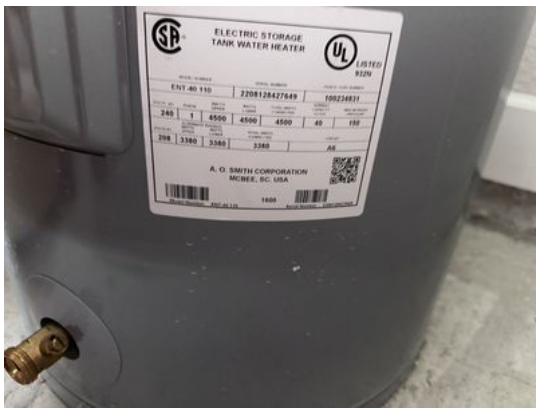
Comment 10 Information

The water heater is a A.O.Smith brand 2022 model located in the garage. Appeared functional and in satisfactory condition at time of inspection.

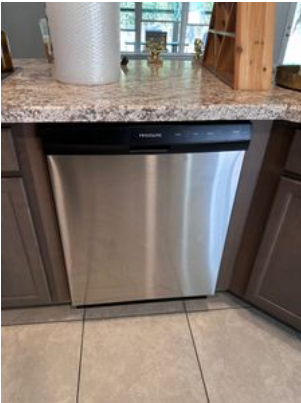
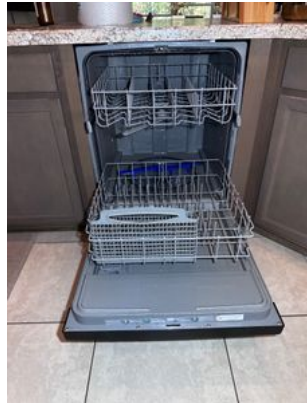
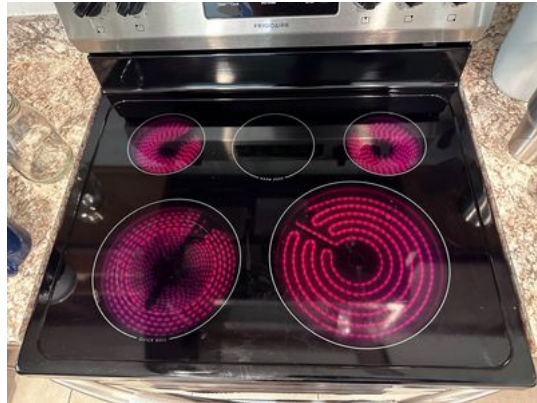
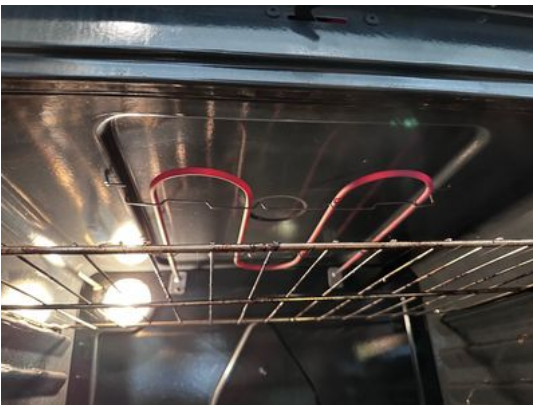
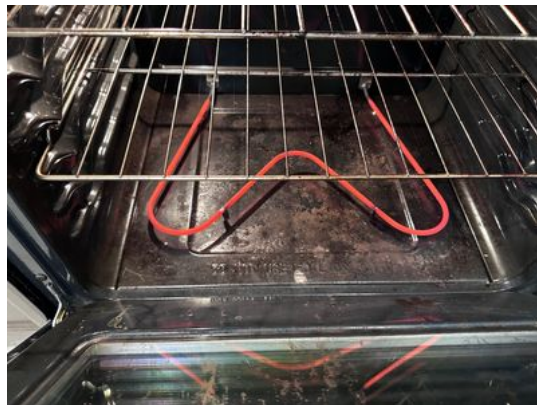
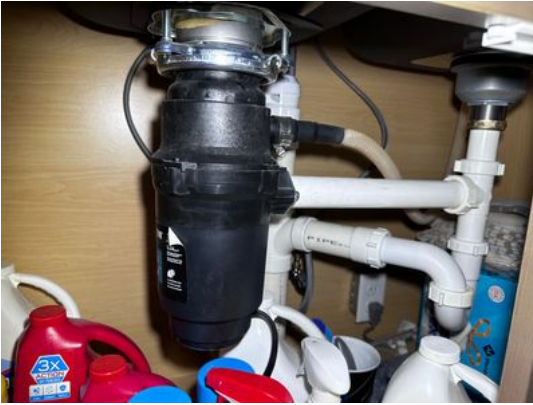
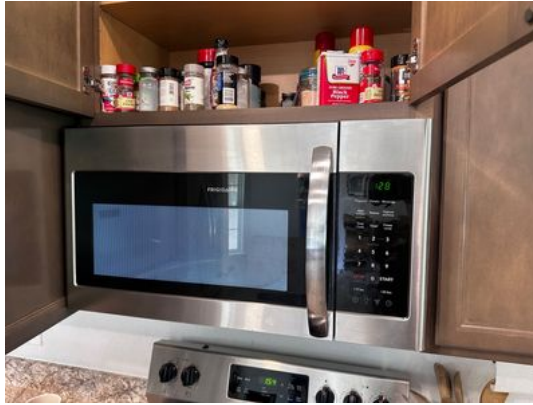
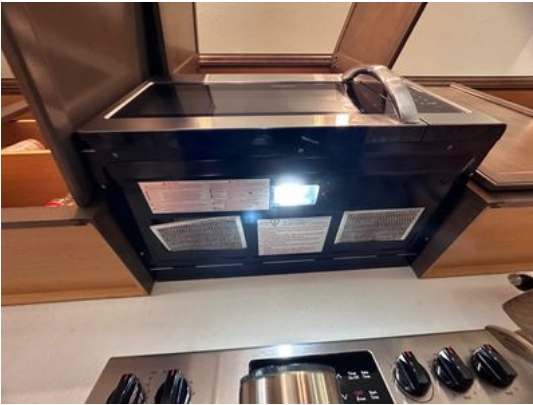
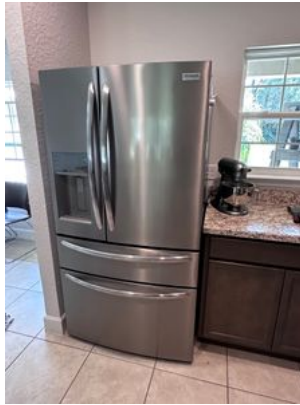
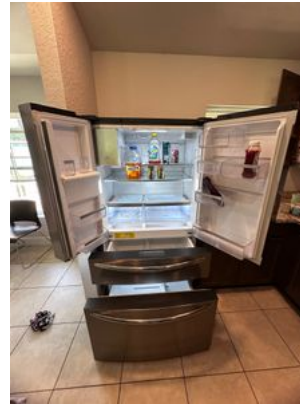
During the home inspection, all the kitchen appliances were thoroughly tested by running them through a cycle, and they were found to be in good working condition. This observation indicates that the appliances, including but not limited to the stove/oven, refrigerator and dishwasher are operating as intended and are capable of performing their intended functions. The appliances showed no signs of malfunction, such as abnormal noises, leaks, or inadequate performance. It is worth noting that this assessment was based on a single cycle test and does not guarantee long-term functionality or future performance of the appliances. However, at the time of the inspection, all the kitchen appliances were deemed to be in satisfactory working order.

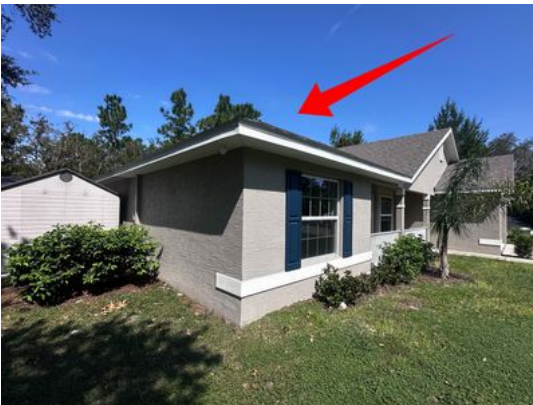
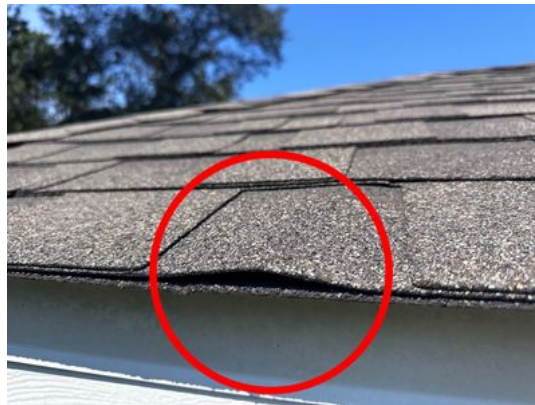
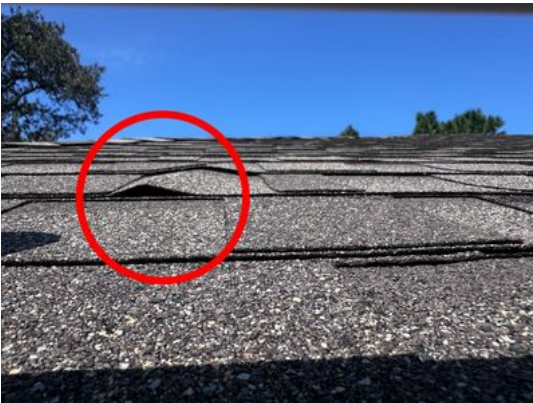
Two popped nails were noted on the roof on the south side. This condition may compromise the integrity of the roofing material and could lead to water infiltration if not addressed.

Recommend having a qualified roofing contractor repair the popped nails and inspect the surrounding area for any additional issues. Proper securing of roofing materials is essential to maintain the roof's integrity and prevent leaks. Regular inspections of the roof are advised to catch such issues early.
